City of Baltimore Wet Weather Consent Decree Smoke and Dyed Water Testing Form

Sewershed: Gwynns Falls

Manhole_ID: S06I_007MH

Test ID: D1032-007009

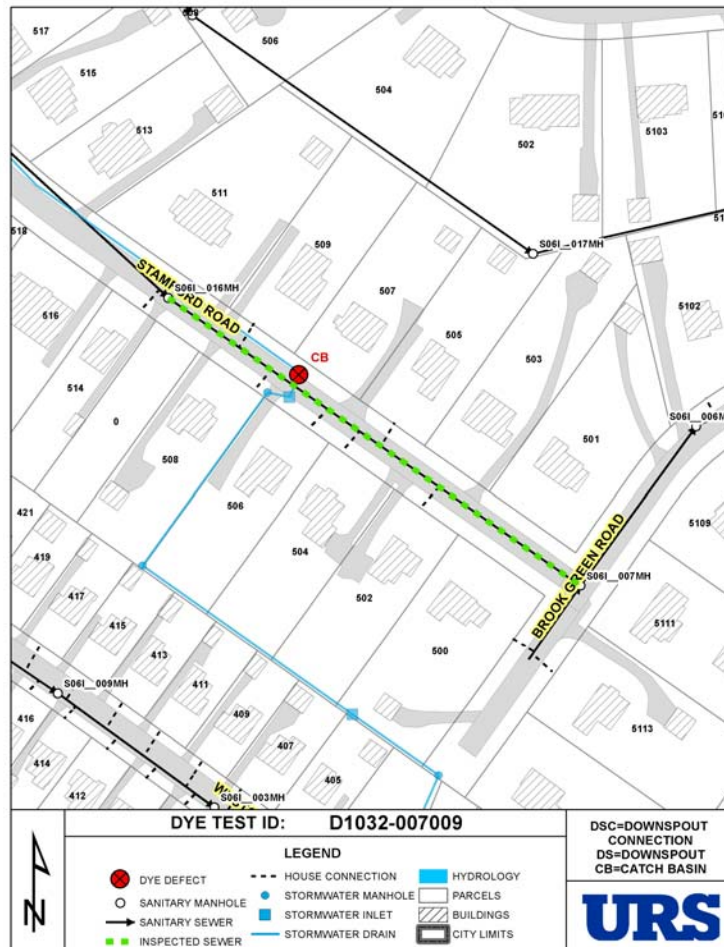
Field Sketch: Show all manholes with Numbers, Blower Placement Locations, Sandbag or Isolation Locations, Street Names, Building Addresses and Locations, Defect Locations and Photo Numbers.

Defect Loc	Obs_ClockFrom	Obs_ClockTo	Observation	Obs_Remarks
0			Start of Survey	
0			Manhole	S06I_016MH
0			Water Level	
90.69999695			Dye Test Visible	DYE SEEN IN TAP
90.69999695	09		Tap Factory Active	
101.1999969	05		Hole	
141.3000031			Dye Test Visible	DYE SEEN IN TAP
141.3000031	09		Tap Factory Active	
146.3999939			Dye Test Visible	DYE SEEN AT JOINT
147.3999939	05		Crack Longitudinal	
147.3999939			Dye Test Visible	DYE SEEN IN CRACK
